RE: Hazardous Materials Survey  
Former Whitepath Fab Tech Facility  
118 Industrial Blvd.  
Blue Ridge, Fannin County, Georgia  
Contour Project No: E21FAN:01

**Hazardous Materials Survey  
Former Whitepath Fab Tech Facility  
118 Industrial Blvd.  
Blue Ridge, Fannin County, Georgia  
Contour Project No: E21FAN01**

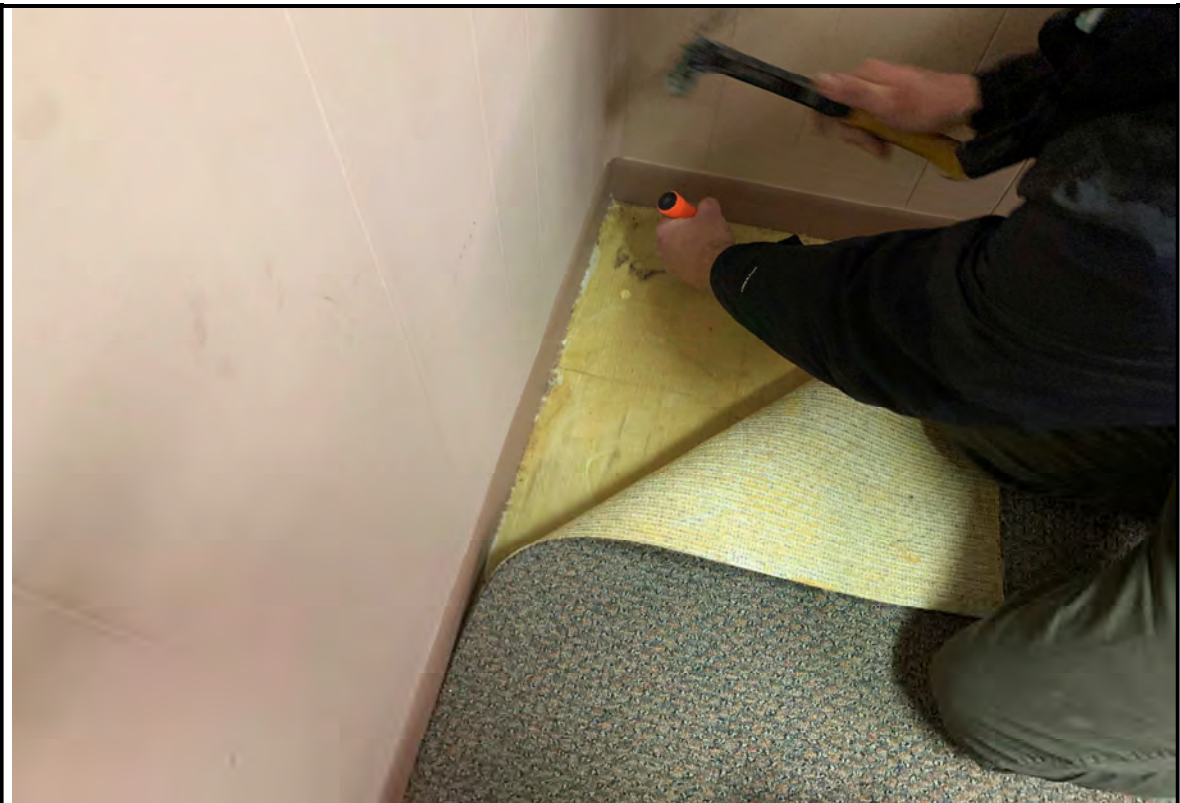
<b>Photograph: 1</b>	View of asbestos containing floor tile located in the front office of the building (Sample WWP-9).		
Former Whitepath Fab Tech	 	 	118 Industrial Blvd. Blue Ridge, GA

Contour recommends that the identified ACM be removed and disposed of by a GA EPD-licensed asbestos abatement contractor prior to the renovation activity that would disturb the ACM identified.

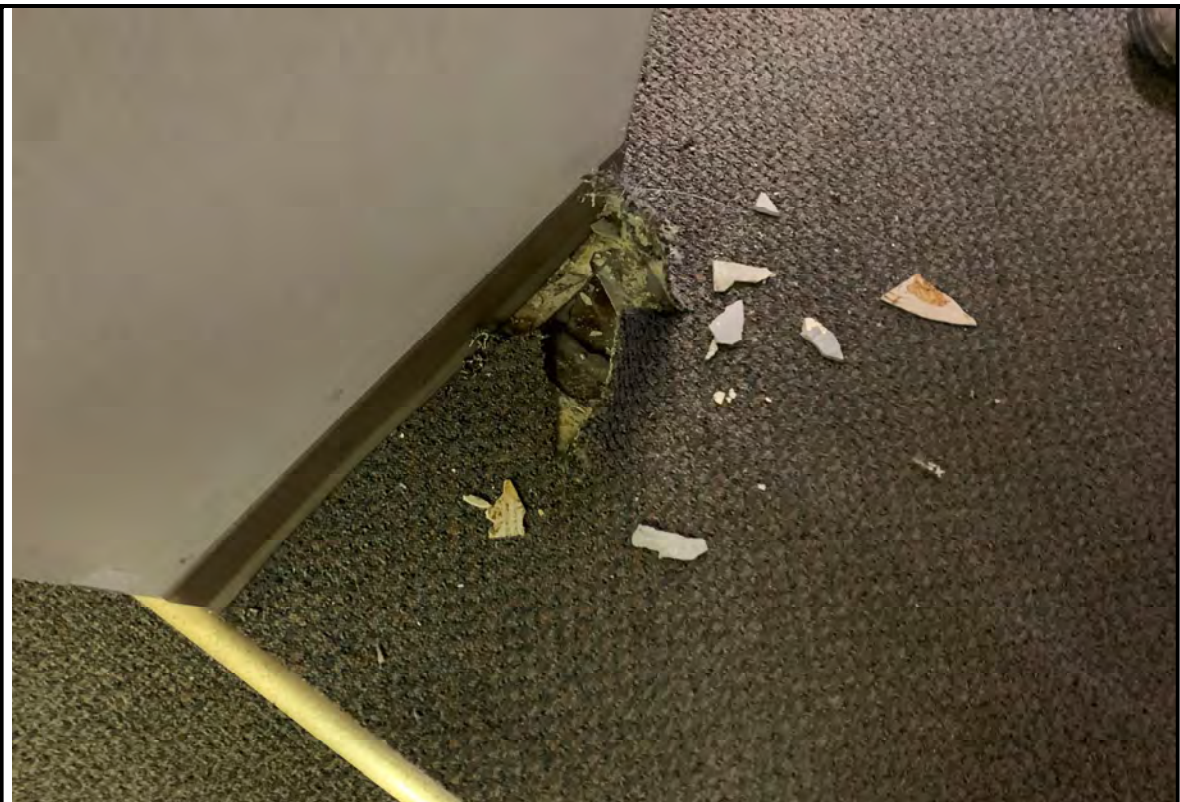
<b>Photograph: 2</b>	View of asbestos containing floor tile located in the front office hallway of the building (Sample WWP-12).		
Former Whitepath Fab Tech

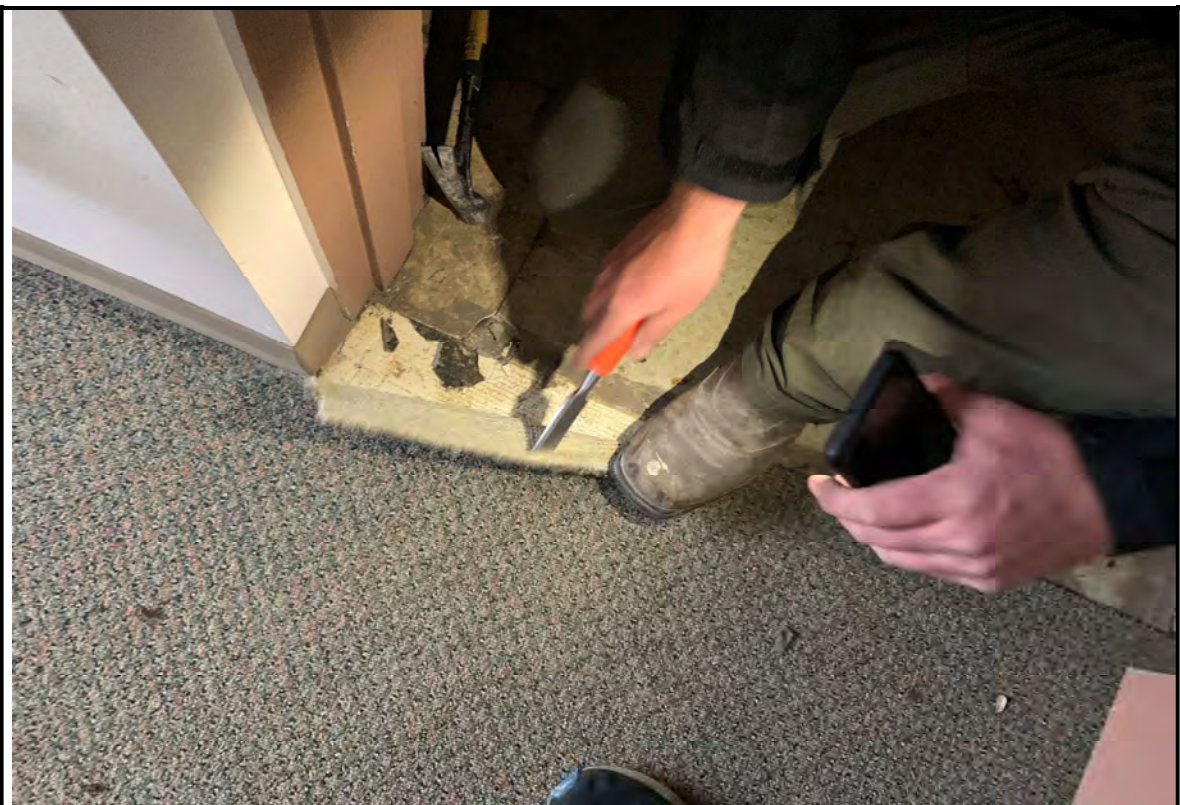
<b>Photograph: 3</b>	View of asbestos containing floor tile mastic located in the engineering office (Sample WP-24).
Former Whitepath Fab Tech	<div data-bbox="665 919 966 1003">   <div data-bbox="876 919 966 1003">A Universal Engineering Sciences Company</div> </div> <div data-bbox="1120 919 1411 1003">118 Industrial Blvd. Blue Ridge, GA</div>

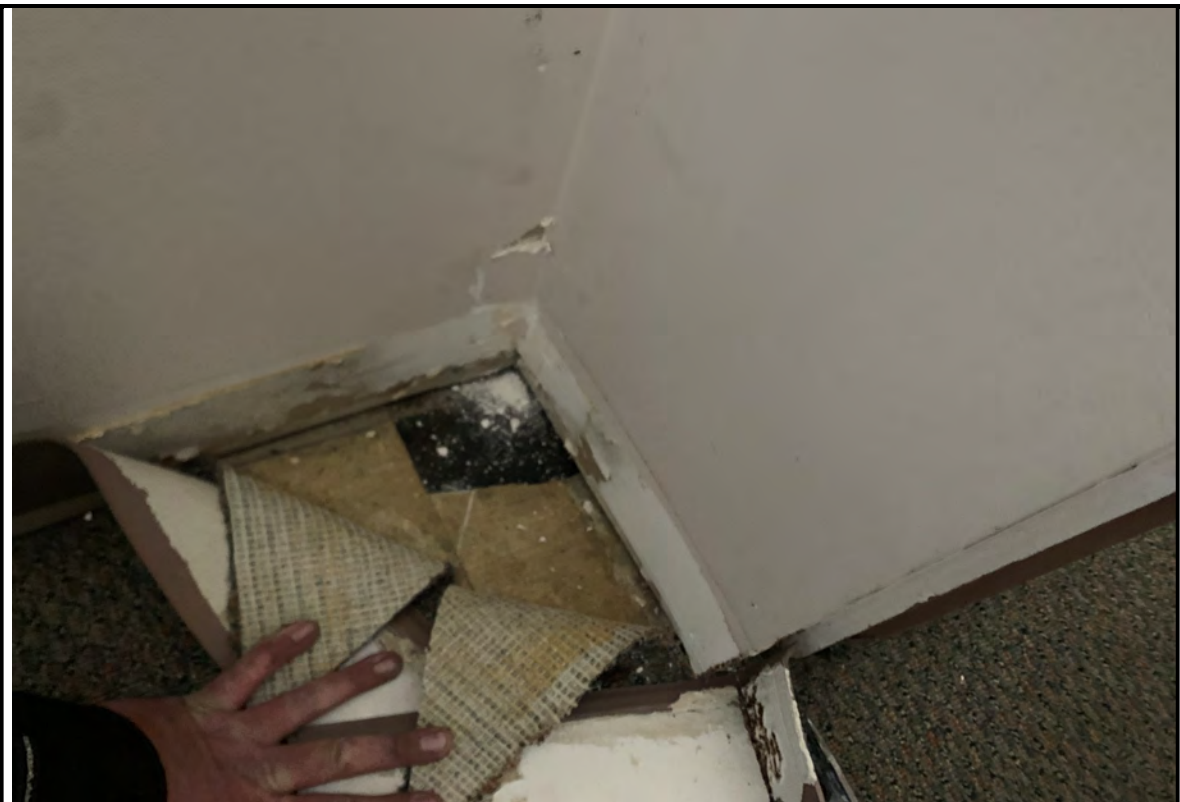
<b>Photograph: 4</b>	View of asbestos containing floor tile mastic located in the engineering office (Sample WP-25).
Former Whitepath Fab Tech	<div data-bbox="665 1908 966 1990">   <div data-bbox="876 1908 966 1990">A Universal Engineering Sciences Company</div> </div> <div data-bbox="1120 1908 1411 1990">118 Industrial Blvd. Blue Ridge, GA</div>

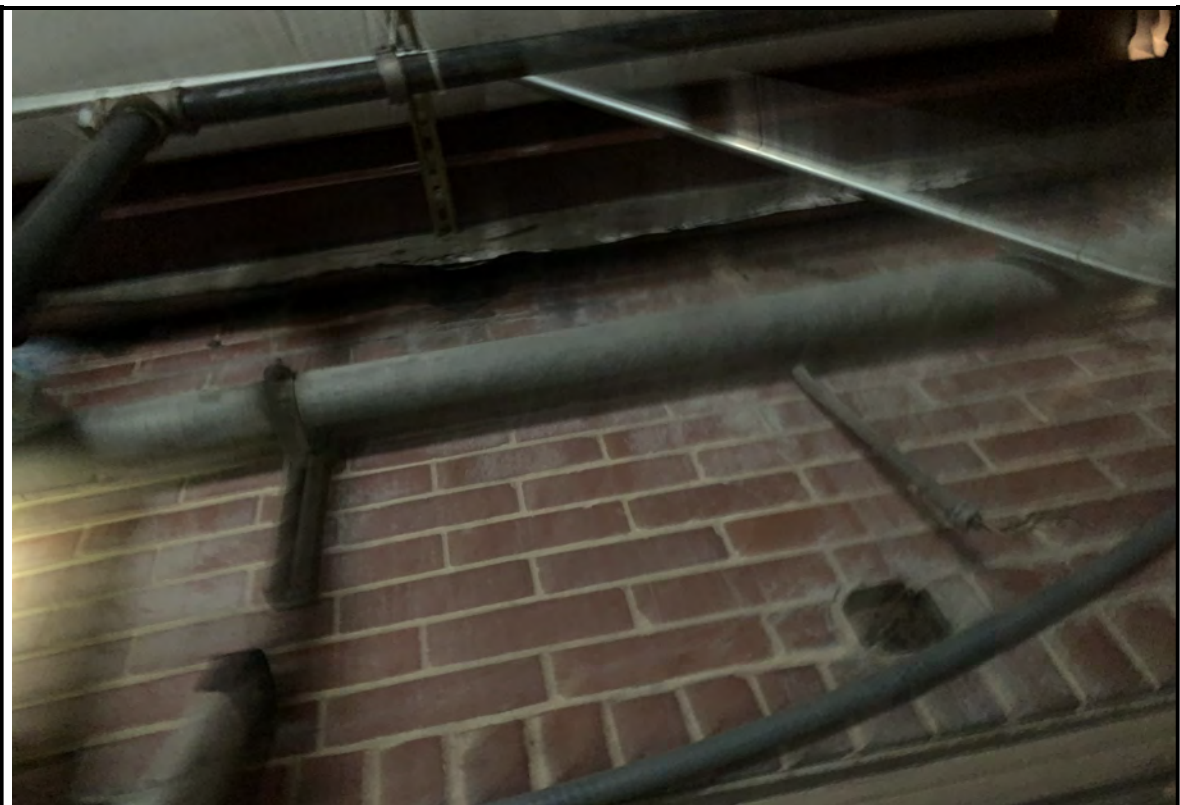
<b>Photograph: 5</b>	<i>View of asbestos containing remnant flashing and roof coating located in the facility shop (Samples WP-36 &amp; WP-37).</i>		
<i>Former Whitepath Fab Tech</i>

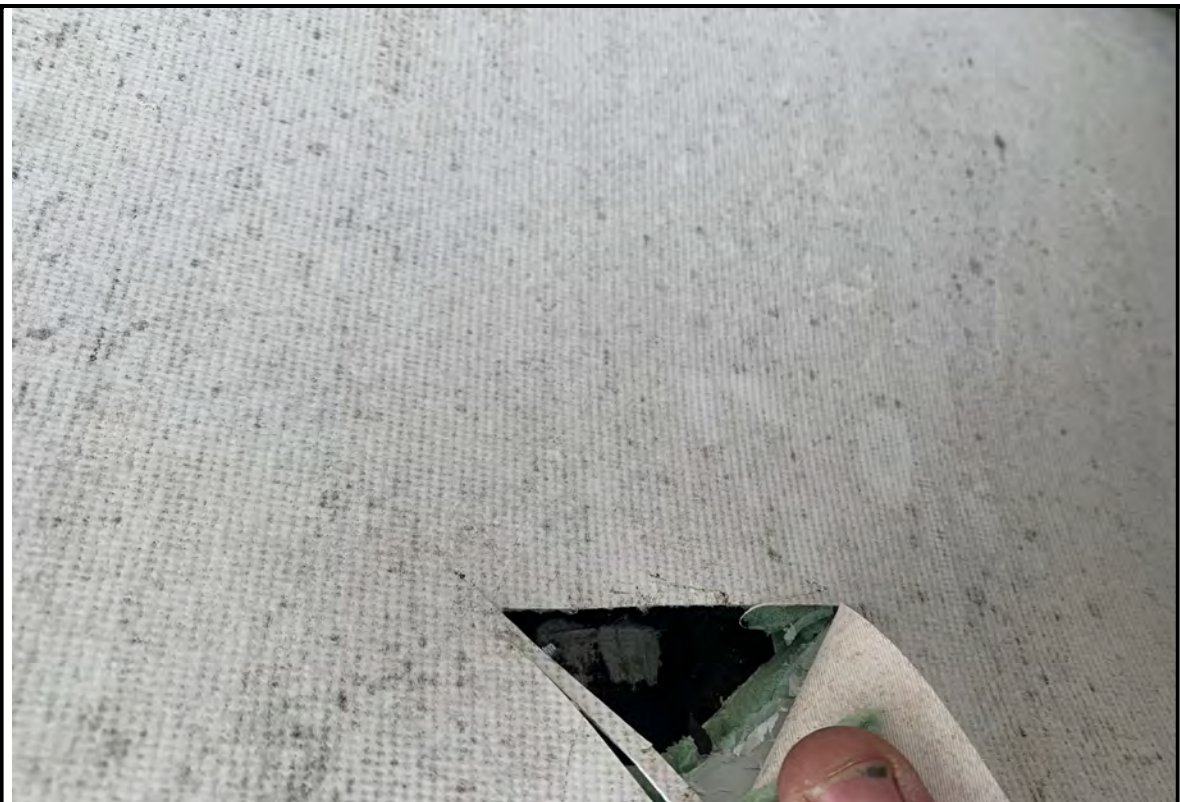
<b>Photograph: 6</b>	<i>View of asbestos containing remnant parapet located on the roof (Sample WP-46).</i>		
<i>Former Whitepath Fab Tech</i>

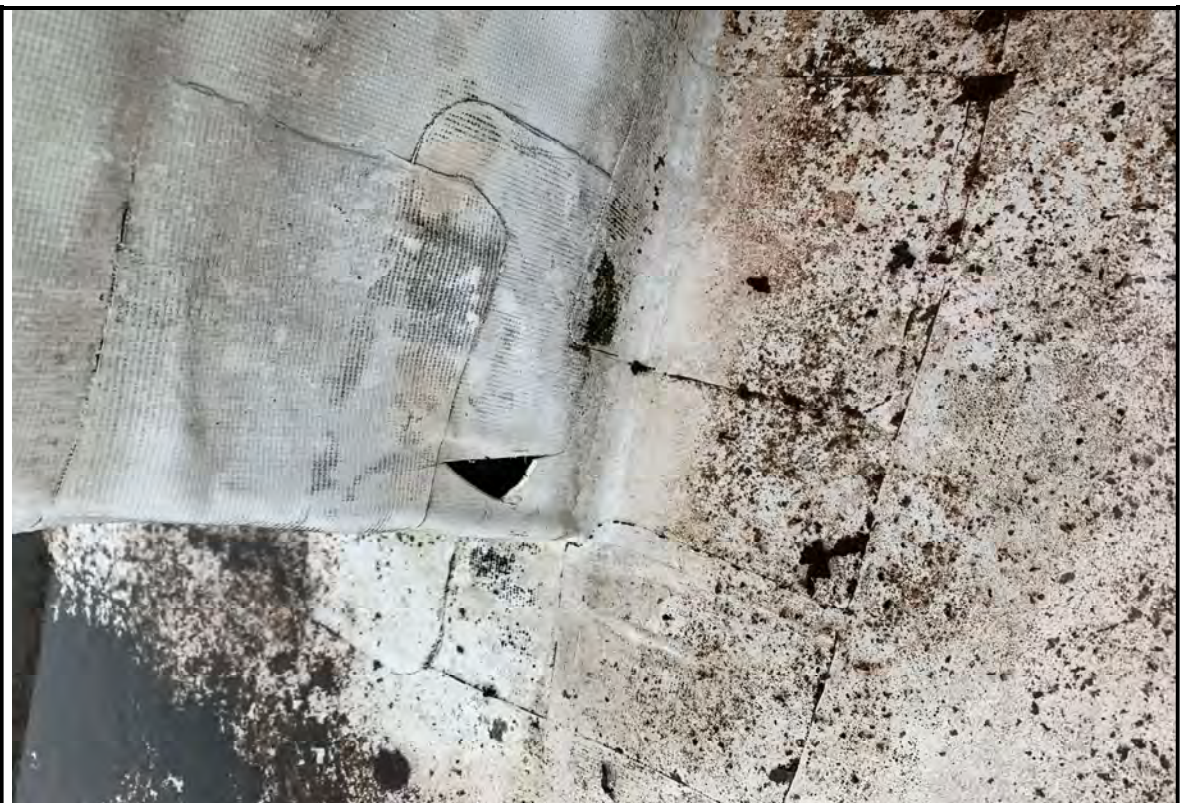
**Photograph: 7** | View of asbestos containing remnant flashing located on the HVAC duct on the roof (Sample WP-58).

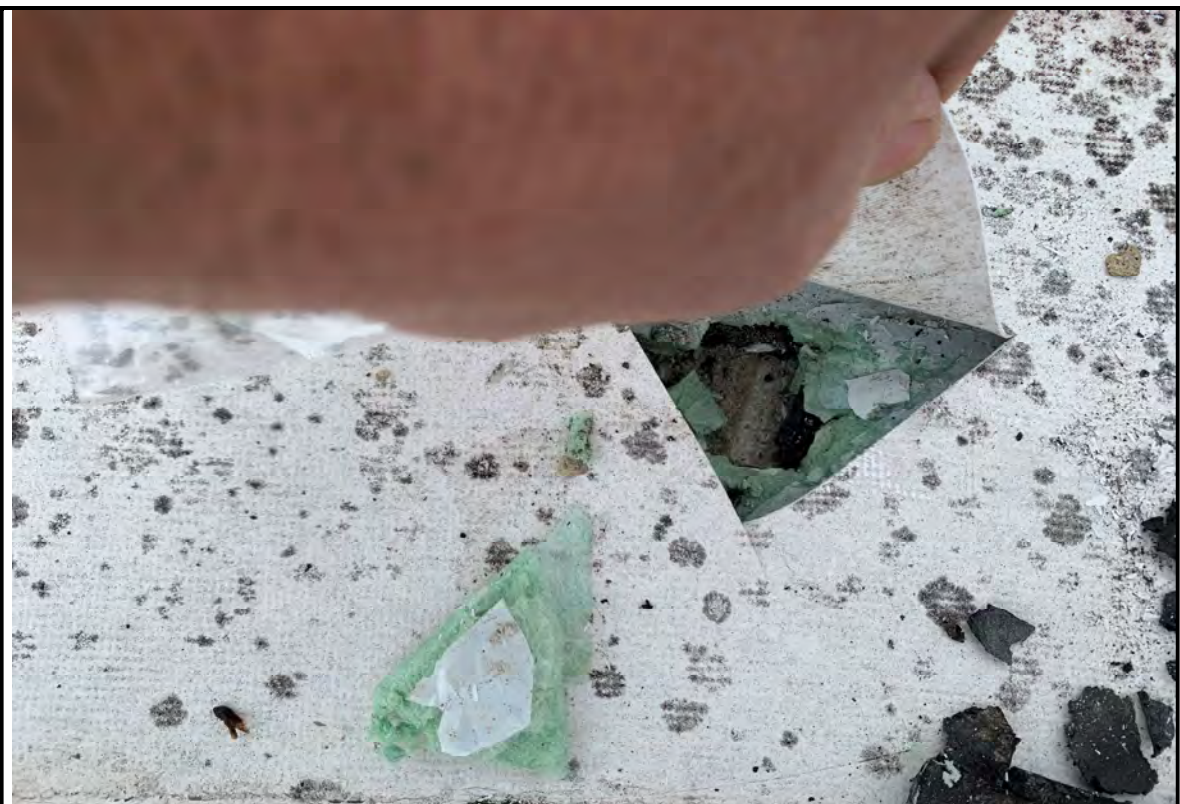
**Photograph: 8** | View of asbestos containing remnant roof located on the roof (Sample WP-59).

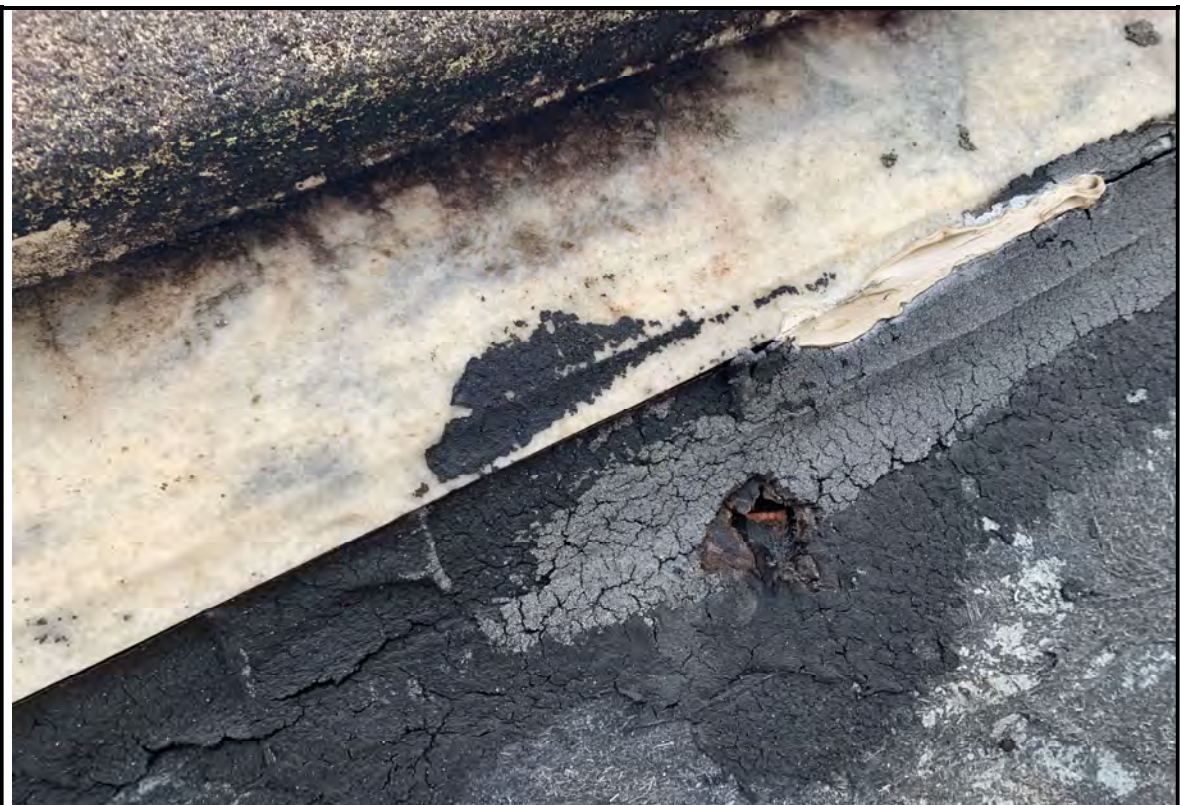
<b>Photograph:</b> 9	View of asbestos containing flashing located on the back of the parking lot decorative parapet (Sample WP-61).
Former Whitepath Fab Tech	<div data-bbox="667 926 967 1003">

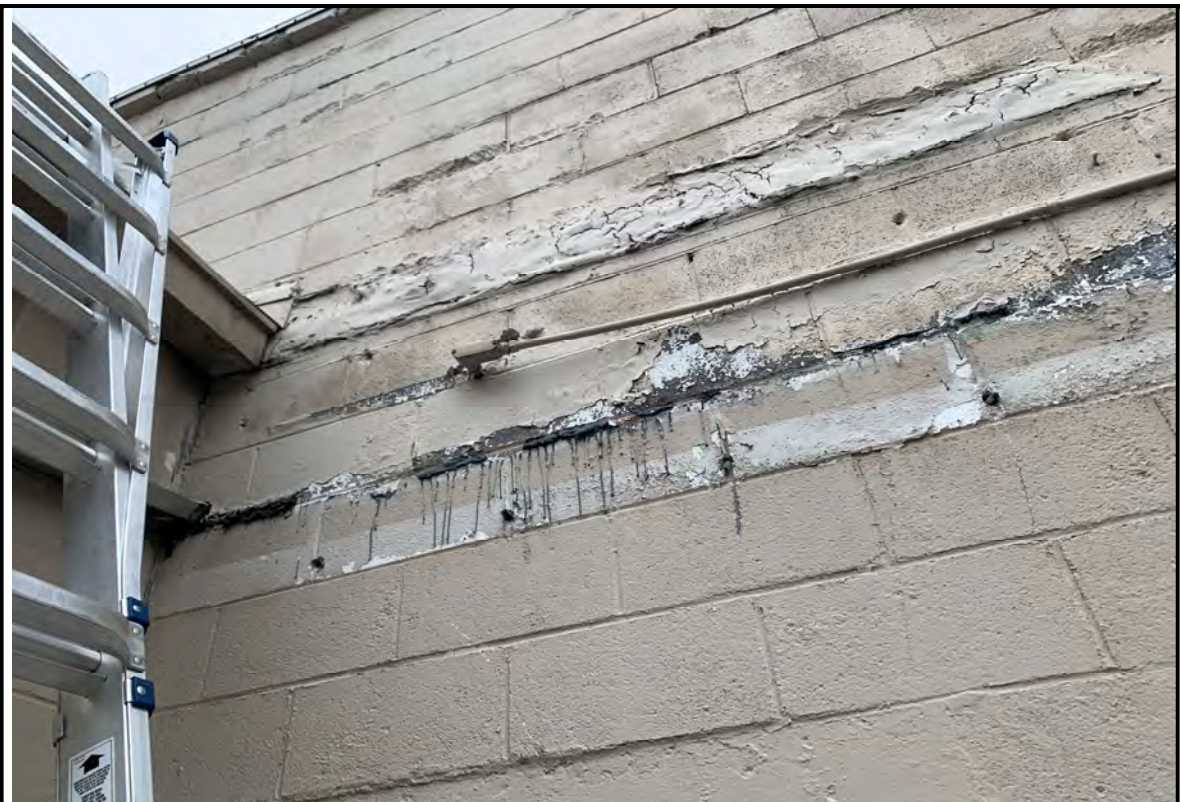
<b>Photograph:</b> 10	View of asbestos containing remnant mastic top & bottom located on the exterior wall of the building (Samples WP-66 & WP-67).
Former Whitepath Fab Tech	<div data-bbox="667 1915 967 1988">

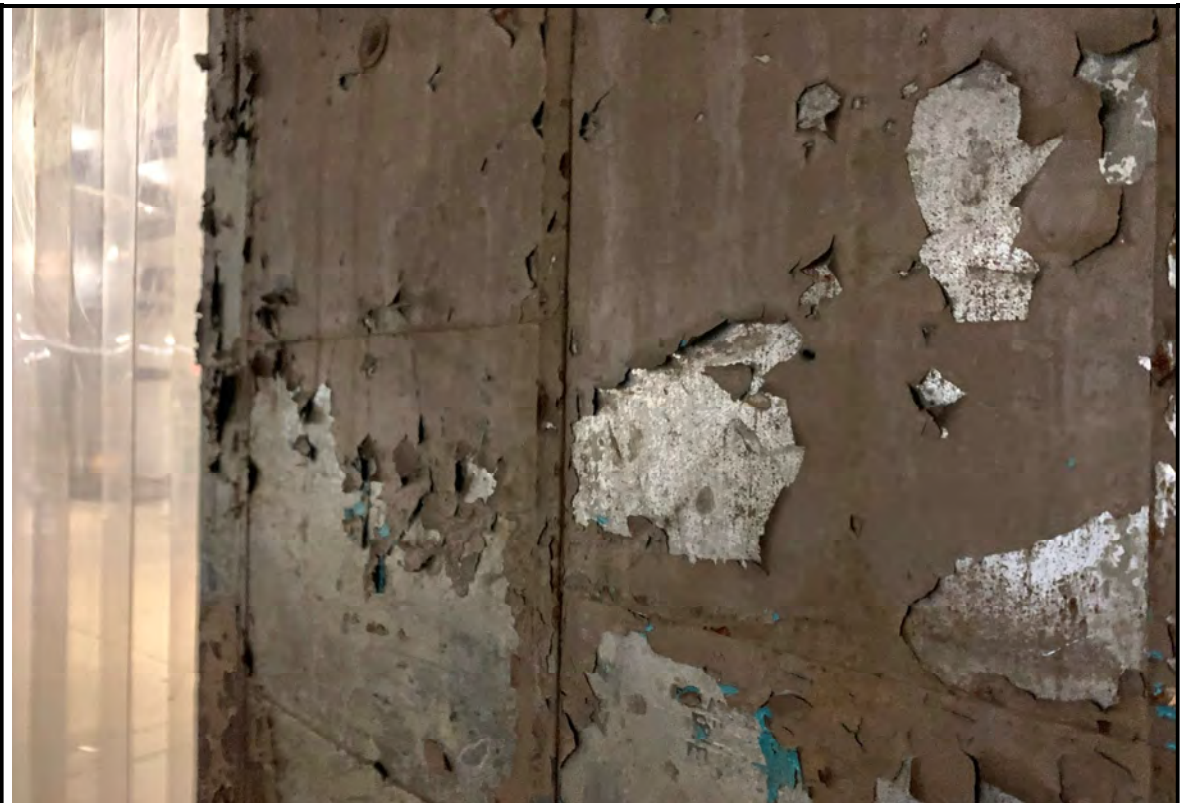
**Photograph: 11** | View of lead based paint on the metal door to the basement (Sample WP-5L).

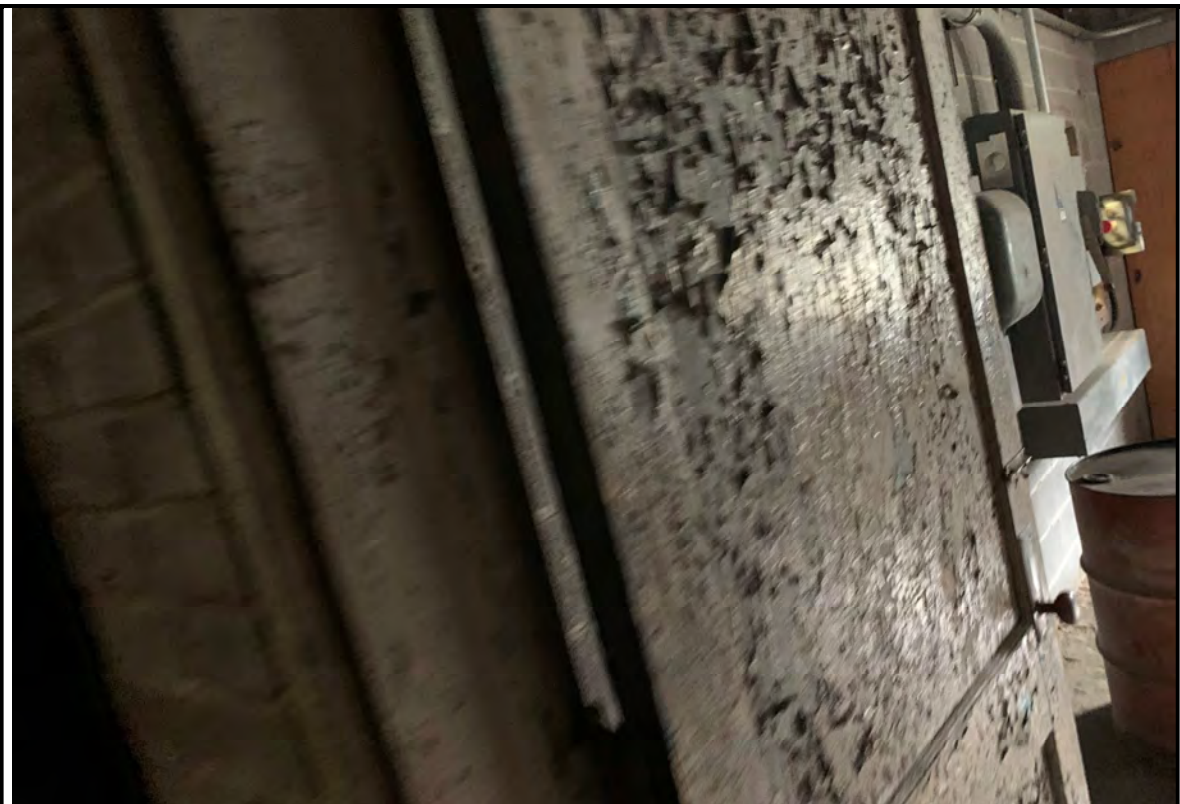
**Photograph: 12** | View of lead based paint on the wood door of the shop (Sample WP-6L).

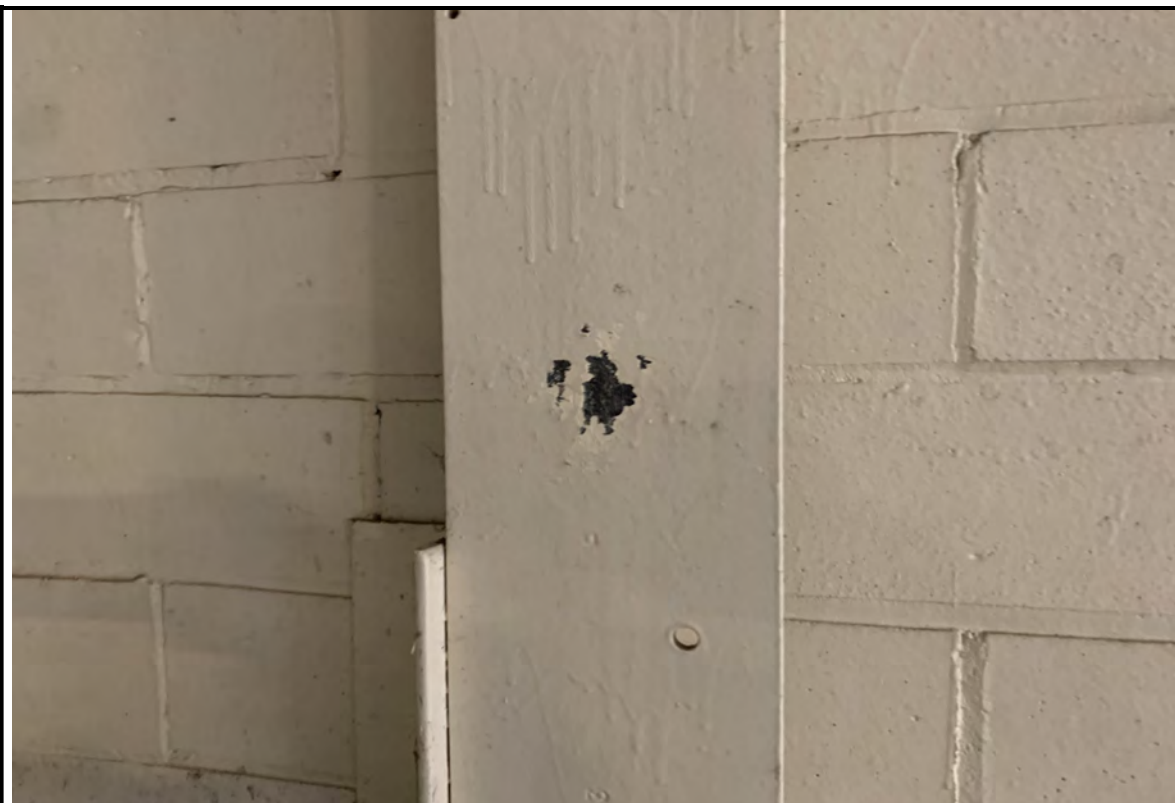
<b>Photograph:</b> 13	View of lead based paint on the steel beam support (Sample WP-9L).		
Former Whitepath Fab Tech

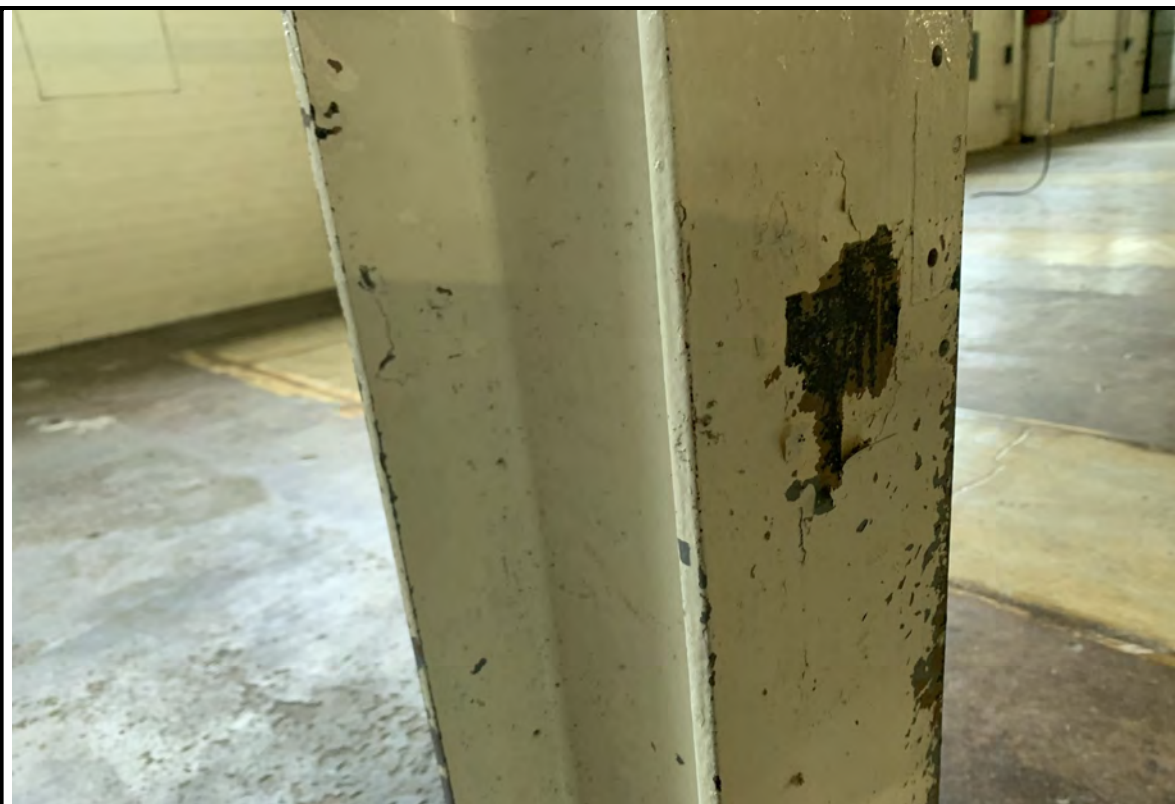
<b>Photograph:</b> 14	View of asbestos containing paint on the steel support beam in the facility (gray and yellow) (Samples WP-12L & WP-13L).		
Former Whitepath Fab Tech	 	 	118 Industrial Blvd. Blue Ridge, GA

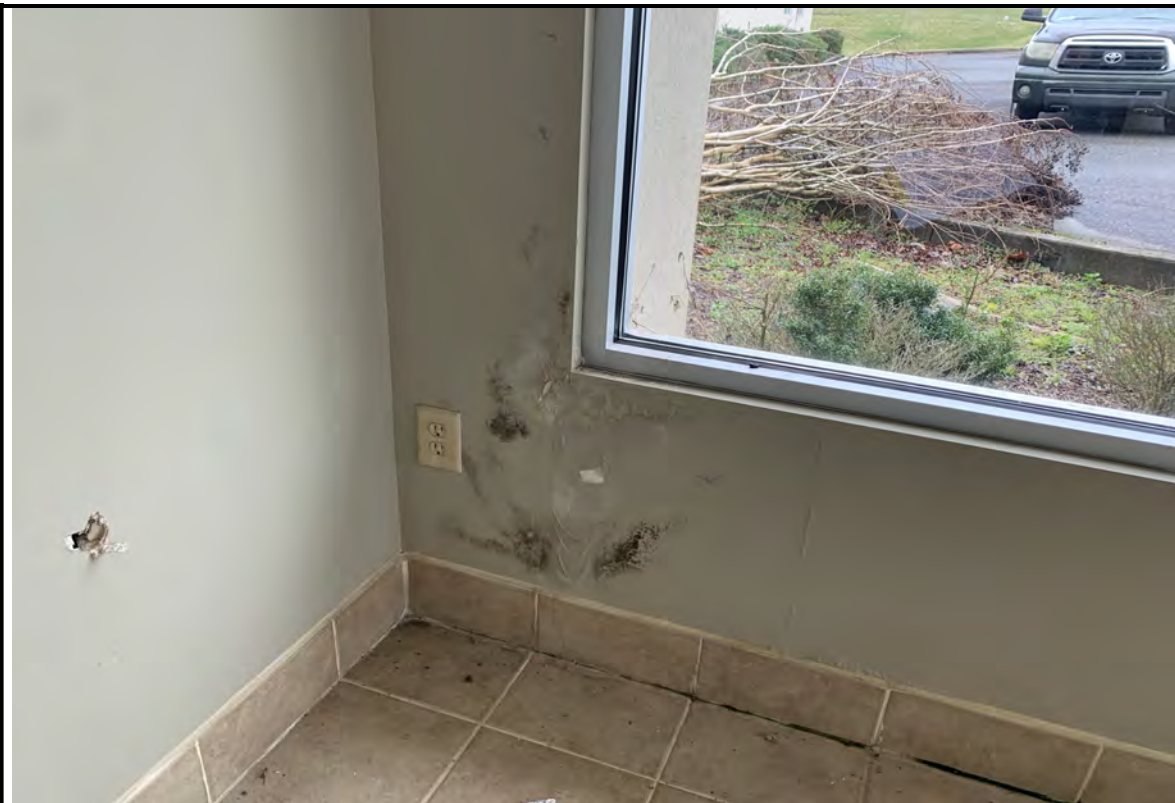
<b>Photograph:</b> 15	View of mold on joint compound in the facility office entrance (Location M-1).		
Former Whitepath Fab Tech

Contour recommends that remediation of the mold impacted areas should follow the Environmental Protection Agency (EPA), Office of Air and Radiation, Indoor Environments Division, Mold Remediation in Schools and Commercial Buildings guidelines to protect the health of building occupants and remediation workers. These recommendations are applicable if the materials are to remain in the structure after the renovation. This may include the CMU walls and wall studs. If the renovation plan includes removal of the nonstructural mold impacted materials, those materials can be handled with the asbestos abatement with worker personal protection and negative air enclosures. Prior to reoccupying or beginning to renovate the structure, Contour recommends that visual and air clearances for mold is conducted.

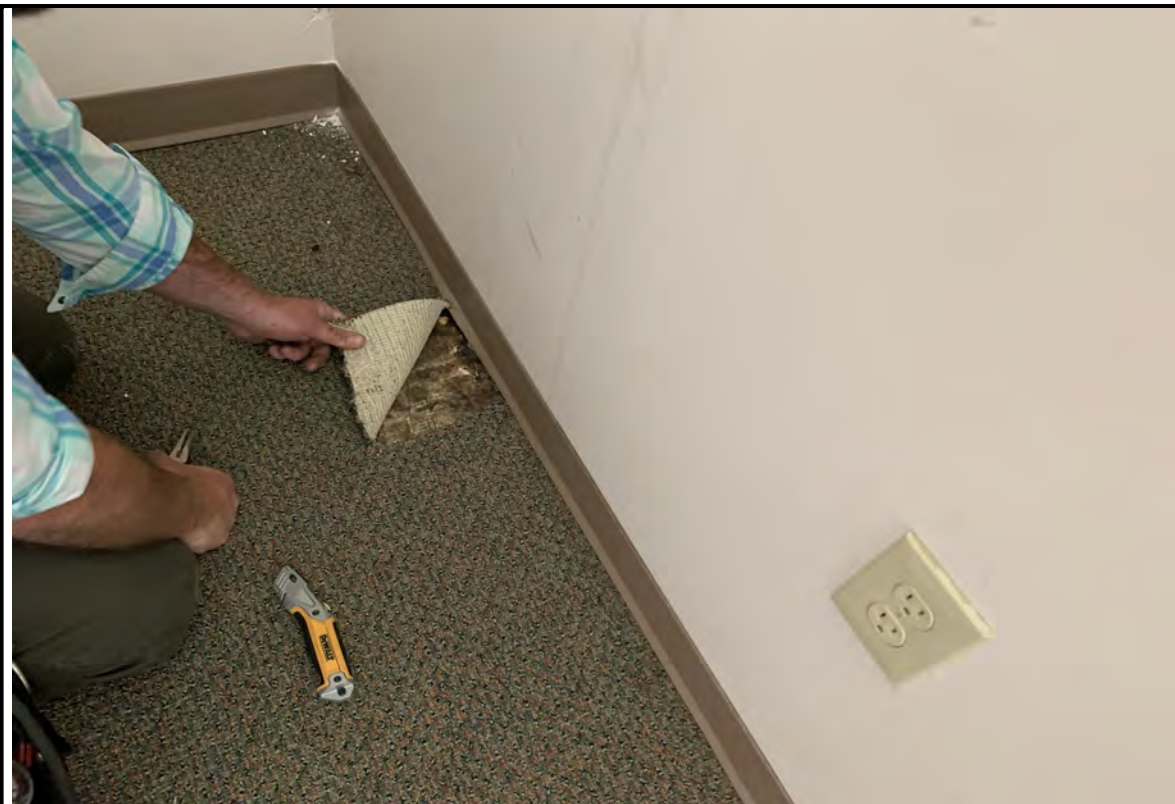
<b>Photograph:</b> 16	View of mold on carpet/carpet glue located in the engineering office (Location M-5).		
Former Whitepath Fab Tech		   	118 Industrial Blvd. Blue Ridge, GA
